KELFORD CAMS

HSV 300kw

LS camshaft upgrade

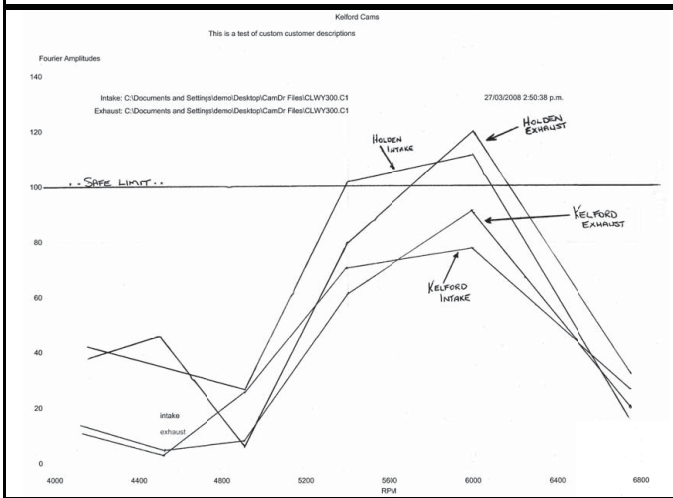
HSV 300kw LS engines are prone to destroying valve springs due to excessive valve train harmonics that spike above 5600rpm. This problem is caused by the O.E camshaft design.

Kelford have designed a replacement camshaft & valve train package that cures this problem. It also provides better performance than the factory camshaft.
